**ENVIRONMENTAL ASSESSMENT  
AND TRAINING REPORT**

**ST. LOUIS JOB CORPS CENTER  
4333 GOODFELLOW BOULEVARD  
ST. LOUIS, MISSOURI**

**SEPTEMBER 13, 1999**

Dynamic Technology Systems, Incorporated  
50 South Pickett Street, Suite 229  
Alexandria, Virginia 22304-3008

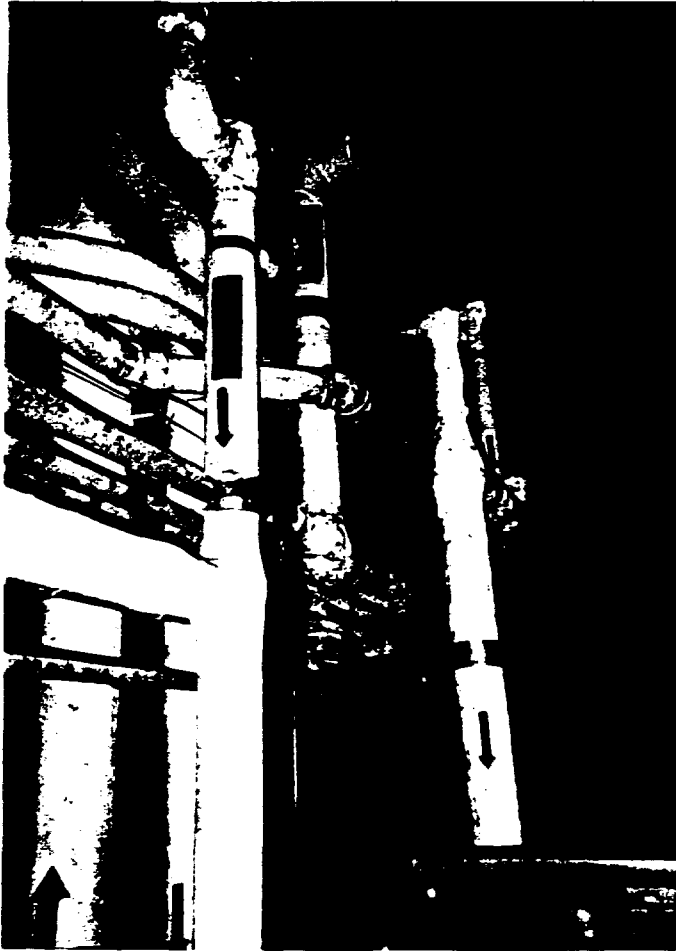
Asbestos was observed in many areas of the Job Corps Center. Not only were probable ACMs evident in pipe insulation and throughout the tunnel areas, but asbestos might also be present in the floor tiles, mastic, dampening felt, and other areas of the Center where students and instructors are active on a daily basis. ACMs that are not friable do not pose an immediate health risk. However, using the Center buildings themselves for construction instruction may inadvertently expose students to ACMs.

Entering the tunnels has the potential to expose the casual visitor and staff member alike to airborne fibers that may be loosened from exposed friable pipe insulation. Pressure differences in the tunnel rooms strong enough to create a perceptible breeze at doorways, and open pas fibers from a room containing ACMs into an area thought to be free of ing signs are posted and most of the doors to the tunnels were locked floor in the basement of the dormitory building was unlocked and open. of some of that pipe insulation.

Figure 2. Possible ACM Pipe Insulation.

It is recommended that a **comprehensive asbestos survey** be performed to identify the type, volume, and locations of all ACMs. Although it is not necessary to remove all of the asbestos in the facility, an **Asbestos Management Plan** should be written that would document: 1) how employees are to be protected from exposure, 2) the procedures that would be followed should demolition or new construction be undertaken (asbestos abatement), 3) where asbestos is located in the facility, and 4) procedures to be followed for contractors working onsite in areas potentially containing ACMs. It is recommended that the area where the boilers are located be paid particular attention because this is the only area of the tunnels where employees routinely work. The boiler room work area should be modified and surveyed so it can be certified as asbestos-free by removing or encapsulating any friable asbestos in the area and sealing off all adjacent areas containing asbestos. There should be a policy established as to when staff members should wear personal protective equipment (PPE) and who is adequately trained to work under those conditions. Procedures for decontamination and emergency measures in the event of accidental exposure should be articulated in the written plan.

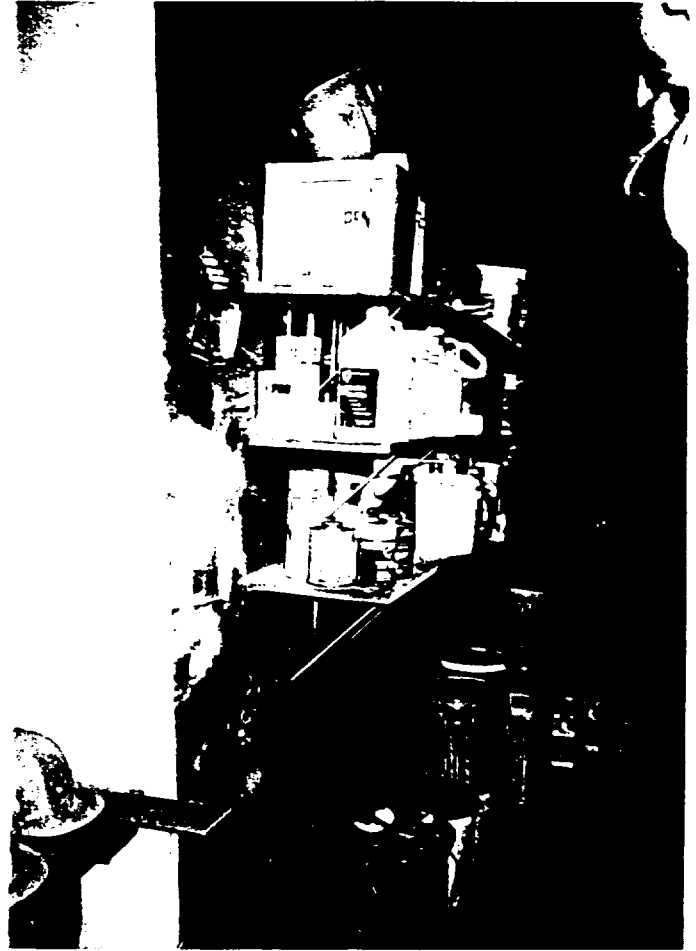
Building 232HBI also contains chemicals being stored. These include paint and thinners, joint compound, adhesive remover, concrete staining and a variety of others. This storage also contained chemicals that were no longer needed.

In either storage area, there was no evidence of releases or quantities of chemicals being stored in improper or unmarked containers. The storage areas were locked and placarded.

Figure 3. Miscellaneous Chemical Storage.

In addition to written policies, it is recommended that materials **purchasing be centralized** so that an accurate inventory of chemicals can be maintained. Chemical storage needs to be rigorously managed and all materials should be identified and labeled. Incompatible materials should be stored in separate areas.
